*Passenger casualties in
non-collision incidents on
buses and coaches in Great
Britain*

PASSENGER CASUALTIES IN NON-COLLISION INCIDENTS ON BUSES AND COACHES IN GREAT BRITAIN

Paper No. 296

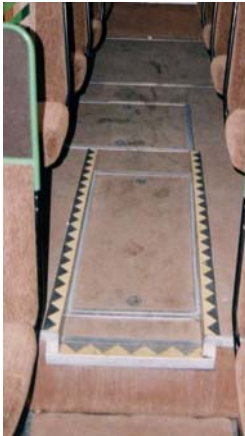
Figure 10.

Uneven floors, especially unpredictable or varying slopes on aisles can present tripping hazards, as they are not expected. New guidelines suggest that floors should not have a greater slope than 3 degrees inside the vehicle (figure 10) and 5 degrees around the door area. Buses with internal steps half way down the aisle can cause falls as passengers are busy trying to find an empty seat rather than looking at the floor (figure 11). The height of any steps within the bus should also be consistent.

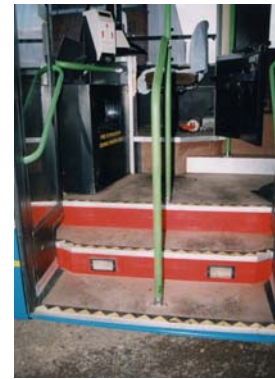
Figure 12.

If there is a large initial step when alighting or boarding, or the step risers are different in height, passengers can lose their balance or misjudge the distance (figure 12). This is especially relevant to the elderly or the encumbered passenger, for example when carrying bags, children or pushchairs.

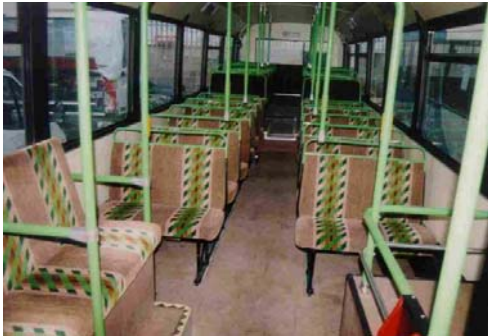
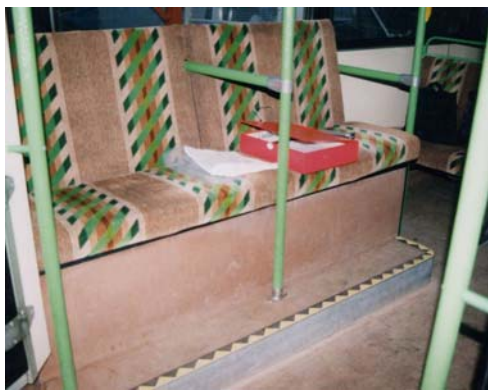
There are unprotected metal grab rails in the areas where seated passengers' heads will naturally fall forward and passengers' upper extremities may hit if they fall over (figures 13 and 14).

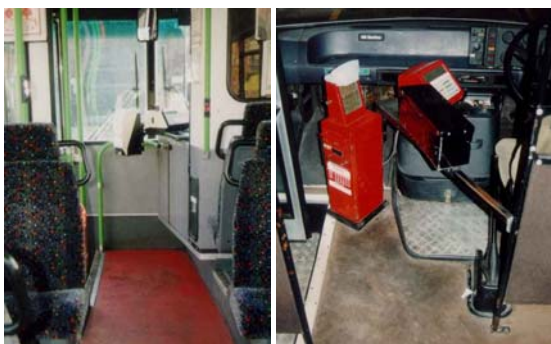
Figure 15.

Ticket machines tend to have hard metal edges that a standing passenger could easily fall forwards and hit, for example, during hard braking (figures 15

and 16). Likewise a boarding passenger could trip and strike the machine. Generally ticket machines, card readers, and bins are not integrated into the design of the bus, they appear to be bolted on afterwards depending upon the requirements of the operator. This inevitably causes them to encroach on the standing area.

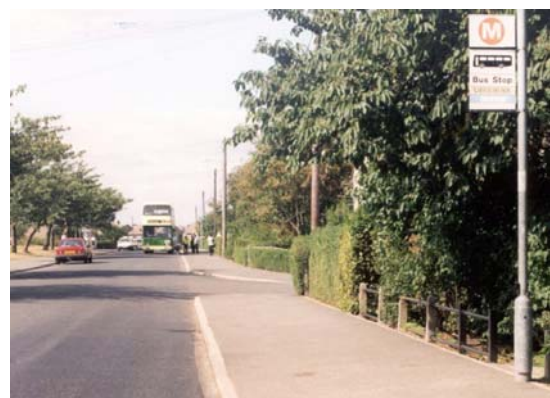
Figure 18. Scene of Accident

A 52 year old female passenger stood up on the bus intending to alight at the bus stop shown here (figure 18). She had shopping bags in both hands.

Before reaching the stop a dog ran across the road causing the driver to brake heavily to a halt. Figure 18 shows the bus in the position at which it came to a stop, so it can be seen that the passenger stood up whilst the bus was a good distance from the bus stop. During the braking action of the bus, the passenger fell forwards and received a fatal head injury from the interior contact shown in figure 19.

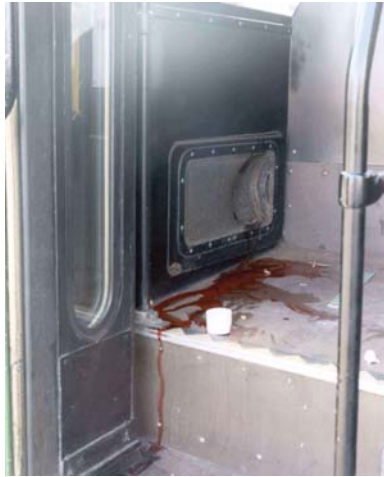
Figure 19. Area of Head Impact

The shape of the head impact can clearly be seen in the grill with the main injury caused by an impact with the rigid metal surround.

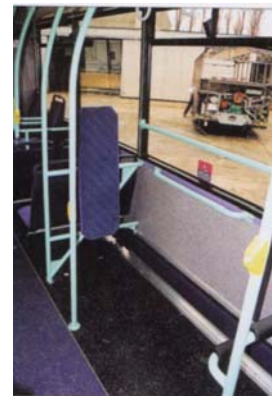
Figure 20.

These new buses have significant advantages on the ease of access for all passengers but especially the less mobile, allowing a wider population to access and use buses, thereby changing the bus user population characteristics. New buses will have low floor access, priority seats and crucially space for wheelchairs and push chairs (figure 20).
