Citation: STYLIANIDES, T. ...et al., 2016. A condition assessment approach for highway filter drains using ground penetrating radar. *Procedia Engineering*, 143, pp. 1226-1235.

A Condition Assessment Approach for Highway Filter Drains Using Ground Penetrating Radar

Theodoros Stylianides¹, Matthew W. Frost¹, Paul R. Fleming¹, Mark Mageean² and Andrew Huetson²
¹Loughborough University, Loughborough, U.K.
²Balfour Beatty Investments UK
t.stylianides@lboro.ac.uk.

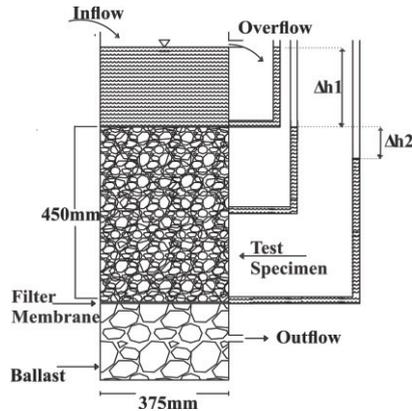
The large-scale permeameter (seen in Figure 1) allows for the measurement of hydraulic conductivity values of samples with a radius of 375mm and depth of 450mm with varying fouling levels under a relatively low constant head. Vertical hydraulic conductivity values (k_v) of different aggregate-foulant mixes are extracted and are used to simulate and define discrete condition states representative of fouling levels mapped to an anticipated level of drainage performance. k_v values are then normalised using an assumed $k_{vmax} = 50 \text{ mm/sec}$ (this extracted by considering the non-linear increase of k_v with decreasing levels of fouling and the maximum recorded $k_v \approx 39 \text{ mm/sec}$ at low levels of fouling– see Figure 4). Water is initially used to fill up the tank and measurements of flow

are completed once samples are fully saturated. A constant flow is achieved using a weir at the top of the tank and the permeability at each fouling state is extracted by measuring the trial time and flow for each test and adopting Darcy’s Law.

Figure 1: Schematic of large-scale permeability tank used in laboratory trials

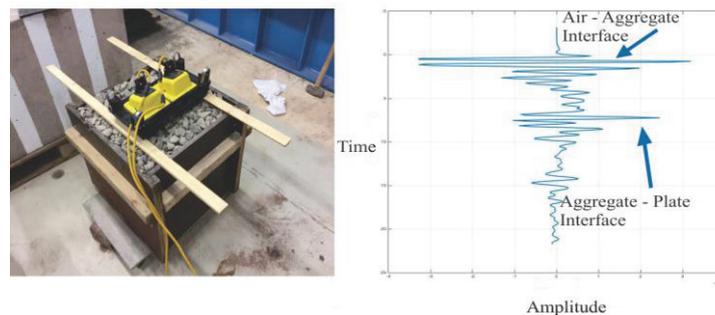
For this set of trials, a $0.5 \times 0.5 \times 0.5 \text{ m}$ container is used to extract dielectric permittivity values by evaluating propagation velocities between known interfaces in the signal's time domain. To distinguish between the required interfaces, a perfect reflector (steel plate) is positioned at the bottom-end of the tank. Figure 2 exhibits the general setup, the ground-coupled EkkoPulse GPR used for this

Figure 2: Container, 1GHz EkkoPulse antenna and typical unprocessed A-scan

set of trials and a time-domain waveform that depicts typical material boundaries in a NDT trial. The container is built using nominal metallic elements to minimise any interference or noise in the extracted and processed A-scans.

The electrical alterations caused by introducing sand, clay and the engineered fouling material along with moisture within the trial tank, cause distinctive reflection and propagation variations that are easily identified in a typical time-domain waveform. Material boundaries can easily be extracted (as seen at Figure 2), due to the anticipated large peaks at air - aggregate and aggregate - steel plate interfaces, using simple post-processing filtering (time-zero correction and bandpass butterworth within the time domain). Figure 5 exhibits how ϵ varies as a function of fouling types and levels. The use of clay fouling results in higher permittivity values and in general terms, a reduced R_{FV} results in lower wave propagation velocities in the evaluated medium and thus higher extracted values of ϵ .

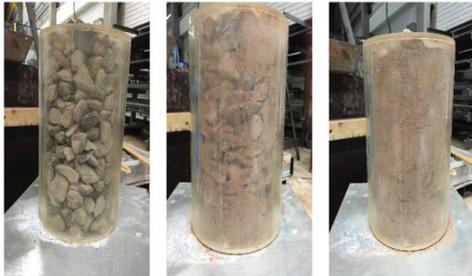
By linking the proposed fouling index to the physical condition of the HFD backfill, a swift evaluation of conditions can be extracted (see Figure 3). In this method, a handful of simple properties of the filter media aggregate and foulants require measuring. The approach is practical and pragmatic and is in fact the first quantitative approach in classifying and evaluating the deterioration characteristics of the aggregate backfill. Using R_{FV} , one can draw conclusions regarding the drainage performance of the HFD backfill and establish discrete asset condition bands if the index is then mapped to a series of permeability trials to measure the anticipated drainage performance drop.

Figure 3 Representation of 3 fouling states using $R_{FV} = 100\%$, $R_{FV} = 50\%$ and $R_{FV} = 0\%$:

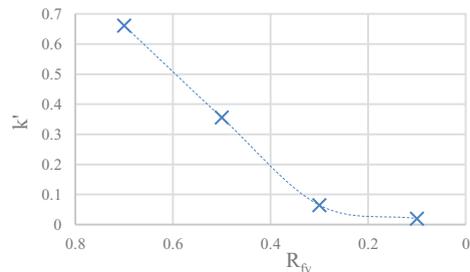
Figure 4: Variation of normalised permeability as a function of R_{FV}

Figure 4 presents this illustrating the normalised vertical permeability value of the fill ($k' = k_v/K_{vmax}$), extracted as a function of the free-voids ratio. Below $R_{FV} = 0.3$, it can be assumed that the material becomes foulant - dominated and presents extremely low (normalised) permeability values; in principle this will result in low levels of performance and will be indicative of a HFD section that can be considered as ‘spent’. While for in-service conditions there will be a number of parameters to factorise when drainage performance of a pavement section is considered, the vertical hydraulic capacity of the aggregate fill can be used to predict the anticipated ‘drainage efficiency’ of a particular HFD trench.

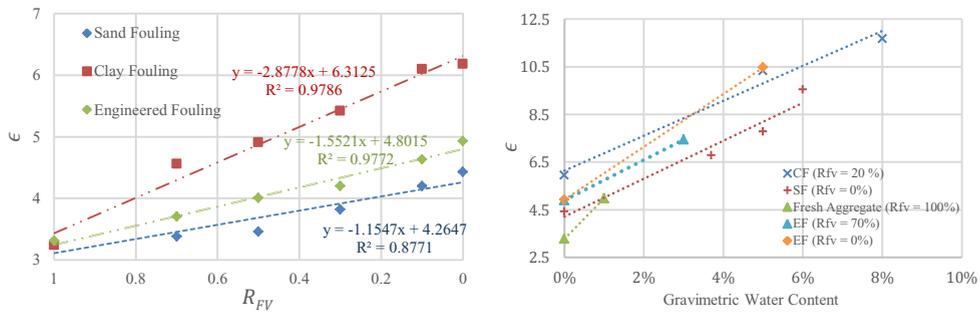
Moisture content plays a significant role in the GPR calibration study. Figure 5 also presents permittivity values as a function of water content for samples with different fouling conditions. It is clear that with increasing moisture levels, the permittivity values of the aggregate-foulant mix shift to much higher levels even in cases of generally low fouling content. At GWC= 3% and $R_{FV} = 70\%$,

Figure 5: Variation of dielectric permittivity as a function of R_{FV} and as a function of different water content levels

using the engineered fouling material, $\epsilon = 7.43$. At $R_{FV} = 0\%$ for a dry, sand-fouled sample $\epsilon = 4.42$; the value moves up to $\epsilon = 9.54$ for $GWC = 6\%$ for the same type and extent of fouling.

It can be generalised that high extracted permittivity values during a condition survey can be attributed to a combination of fouling levels and moisture content. With increasing clay content in the fouling mix, the parameter gets even larger but the data suggests that the wave velocity is more sensitive to moisture rather than fouling levels (or types). The highest extracted permittivity $\epsilon = 11.67$, occurs at $R_{FV} = 20\%$ using clay fouling and an extracted gravimetric water content of 0.08. Compared to fresh aggregate ($\epsilon_{fresh} = 3.28$) this is the largest deviation of relative permittivity recorded in this study even though higher values should in principle be extracted with increasing levels of moisture or fouling in a HFD trench.
